OFFICERS CLUB BUILDING No. 114

HISTORIC STRUCTURE REPORT

Sandy Hook Unit
Gateway National Recreation Area

June 2006

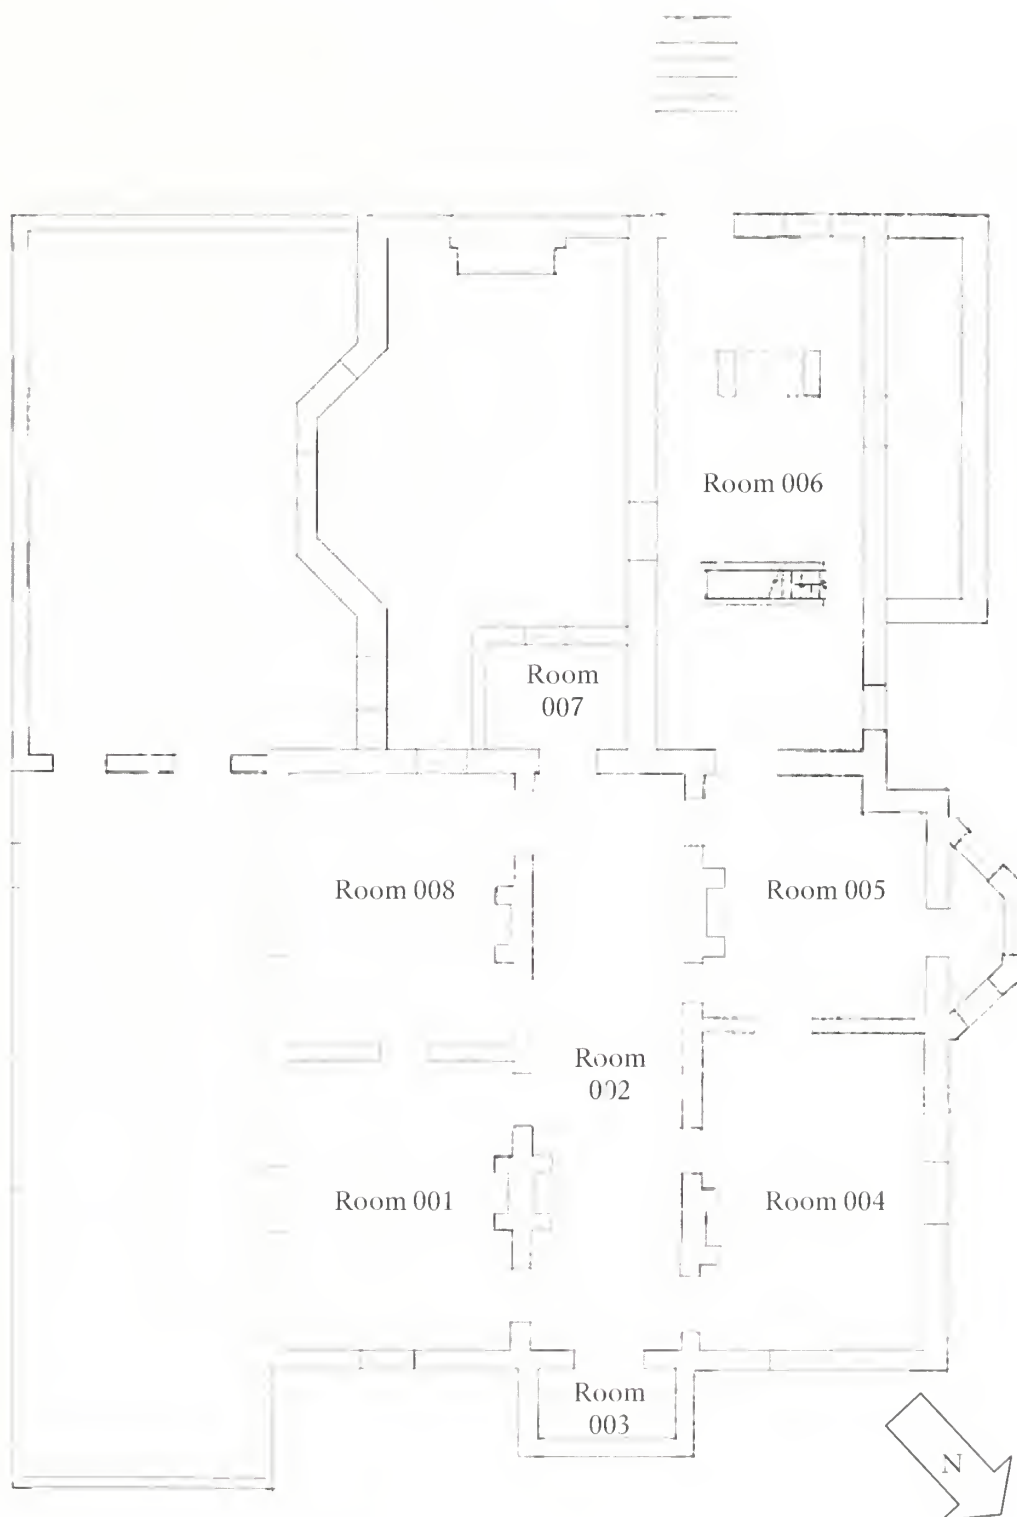
Figure 88. Officers Club, basement plan annotated with room numbers (not to scale).

There is a full basement under the original sections of the building and crawlspaces under the additions (fig. 55 and Appendix A, fig. 88). The original stairway from the basement to the first story of the rear ell has been removed. Thus, the only access to the basement is through the west- elevation bulkhead. Several of the doorways in the brick bearing walls and partitions of the basement are sealed off with cinderblocks. Some of the original basement windows are closed off with brick, and the windows facing the exterior are covered with plywood. As previously mentioned, a large portion of the exposed framing was charred by fire. In Room 001, some of the framing has been strengthened by the addition of support posts and extra joists. The ceiling in the center hallway, Room 002, appears to be composed of fireproof asbestos panels. The basement floors are covered with cement, except in Room 008, which is paved with pieces of brick.

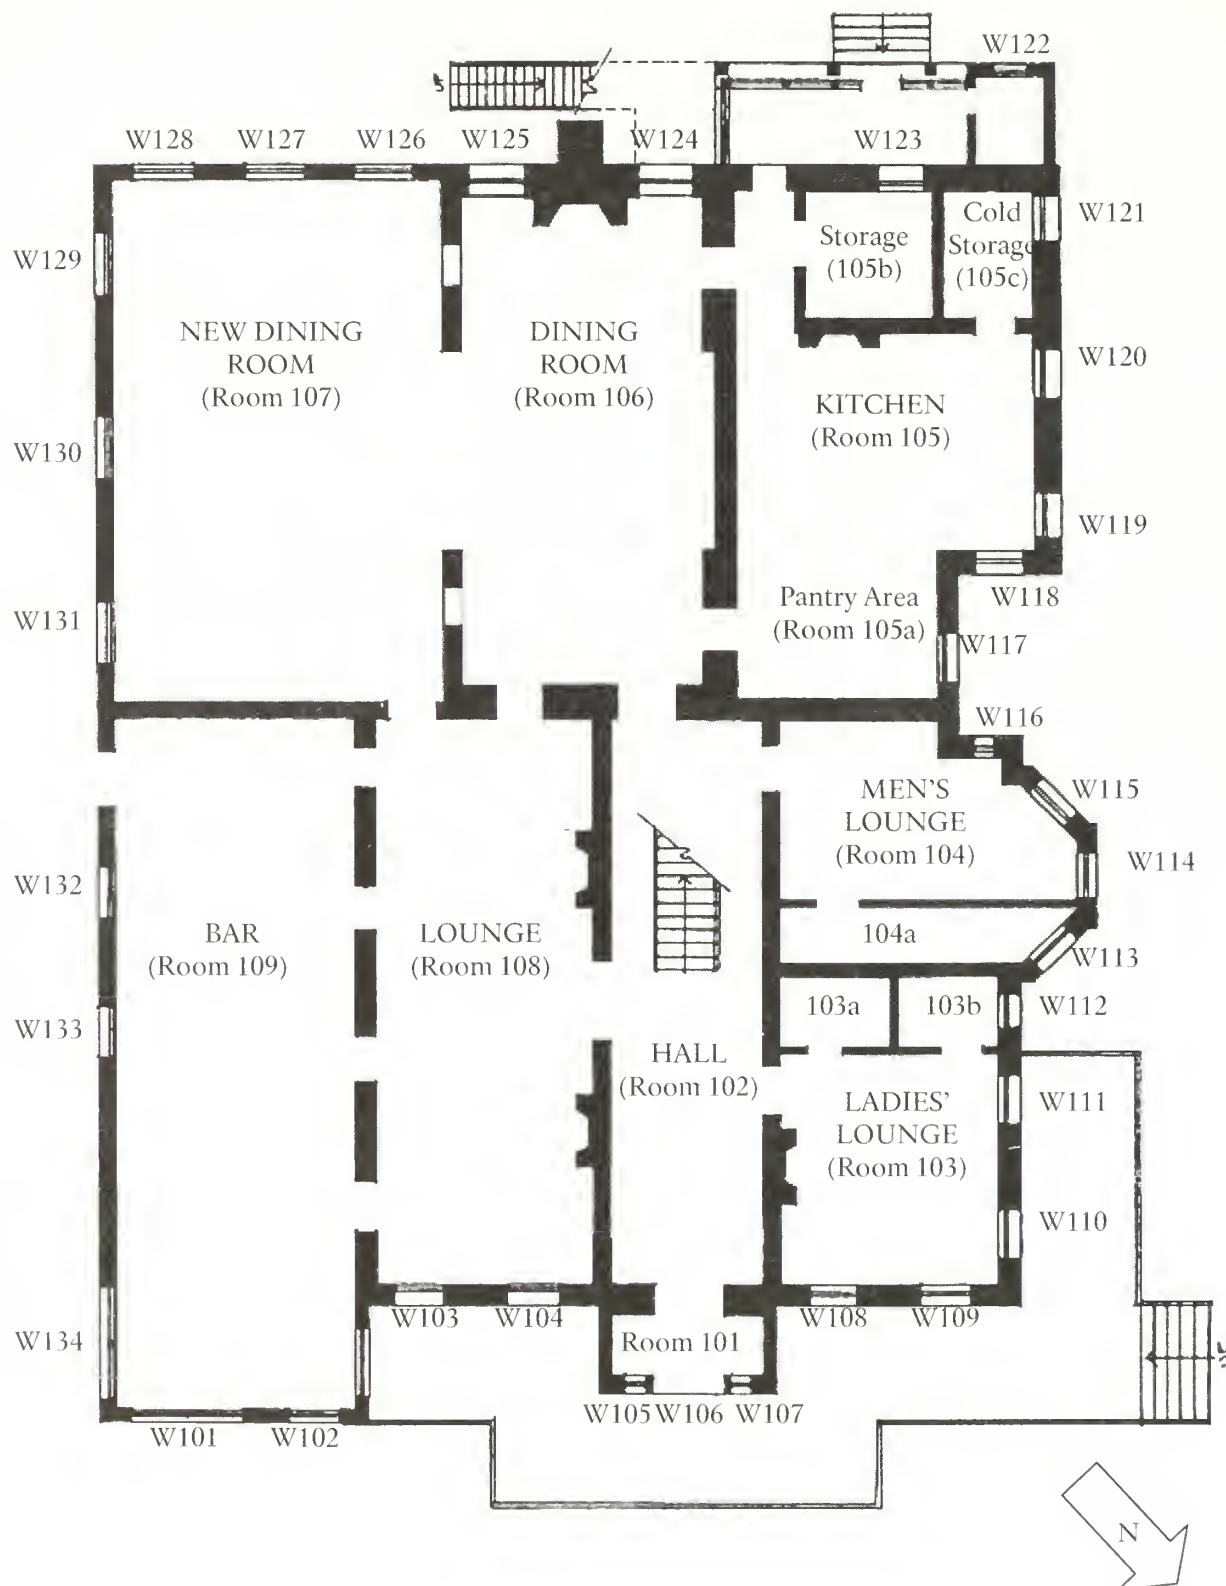
Figure 89. Officers Club, first-story plan, annotated with 1959 room names and room and window numbers (not to scale).

The plan for the first story of the Officers Club included a center hallway defined by the interior east- west bearing walls (figs. 13 and 73, and Appendix A, fig. 89). Projecting from the east end of the hallway was the entry vestibule. North of the hallway were a “Sitting Room” at the front of the building and a “Dining Room” behind it. These were separated by closets (later altered to bathrooms).⁵⁹ As proposed, the area south of the hallway contained two rooms, an “Office” in the southeast corner and a “Board Room” in the southwest corner.

The current plan of the first story appears to be relatively unchanged from the military usage of the Officers Club (Appendix A, fig. 89). The front entrance and vestibule, leading to the east-west center hallway, remain important features of the plan. The primary rooms on first story flank the center hallway, as they did historically. The demolition of the rear stairway and partitions in the Kitchen area (Room 105) has created a much larger service area that does not reflect the historic appearance. However, this does not adversely affect the interpretation of the first story.

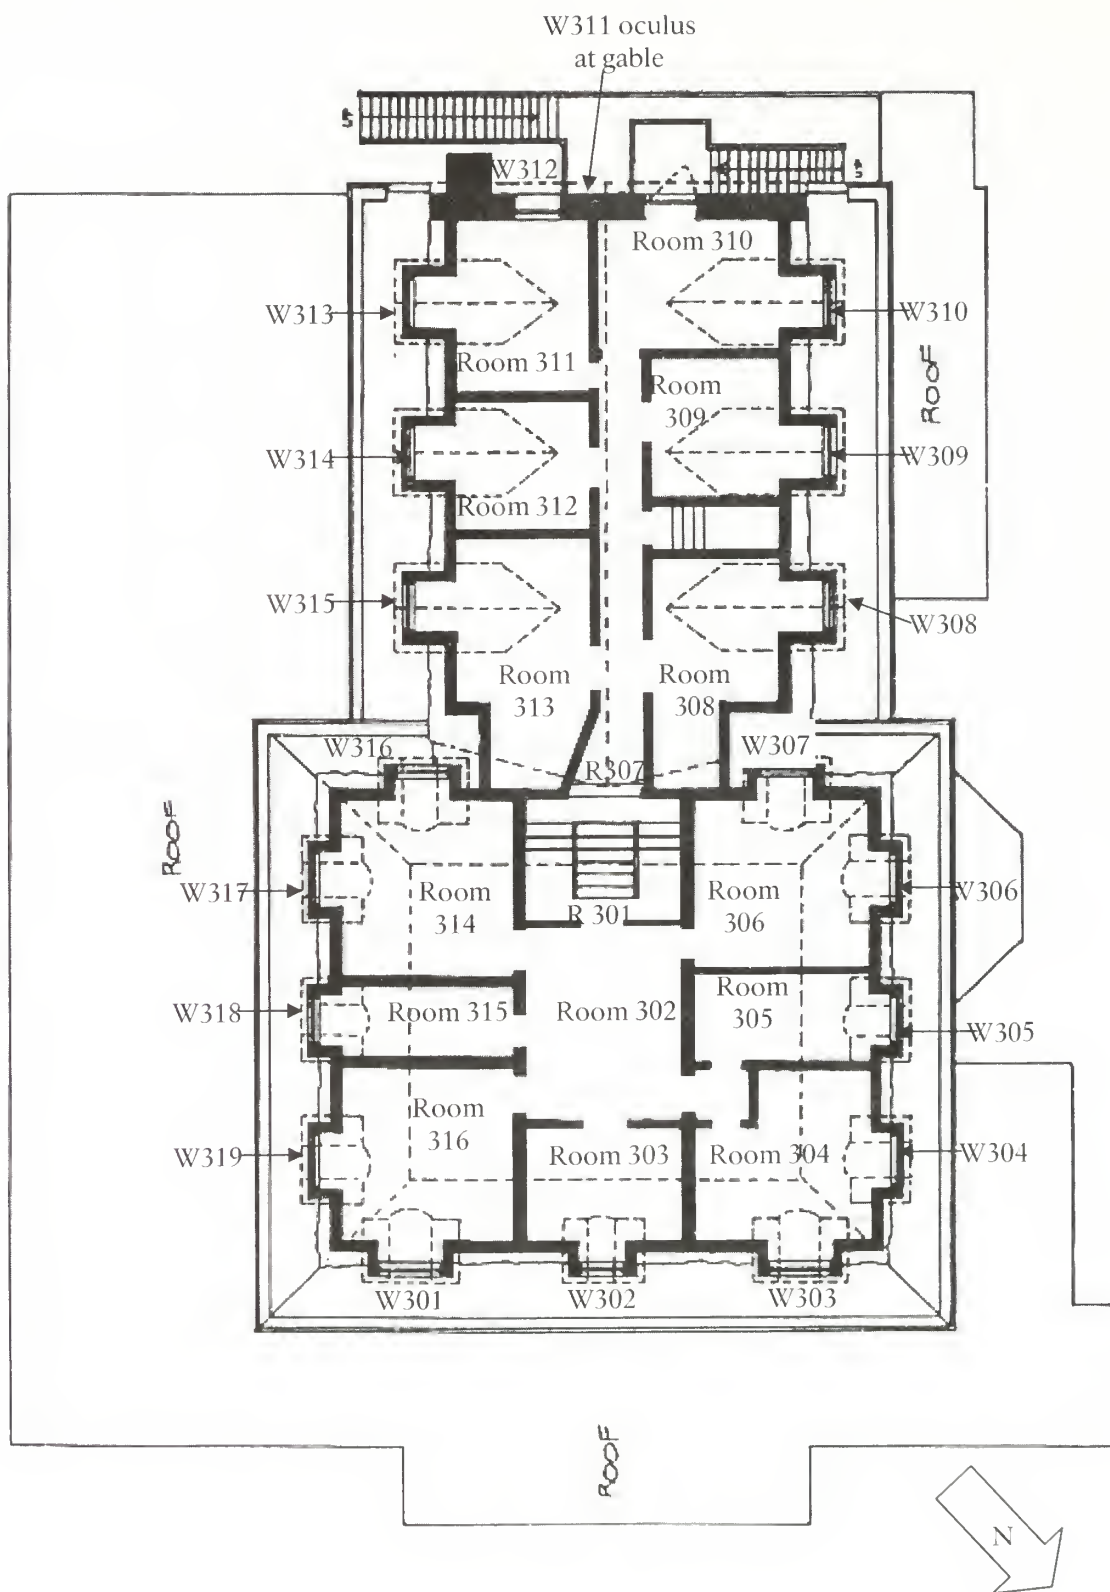
Figure 91. Officers Club, attic plan, annotated with room and window numbers (not to scale).

The extant building materials in the attic of the Officers Club indicate that the current room plan of the main block is similar to the original 1878 layout (Appendix A, fig. 91). The bearing walls that delineate the east- west center hallway continue at the attic level, with rooms flanking the hallway. The list of room names and sizes from the 1920's supports the physical evidence. Apparently one bathroom has been removed since then, which may have been located between Rooms 304 and 305. A partition was added across the center hallway (Room 301) to restrict access from the second story to the attic- story rooms. This created an ancillary cross hallway (Room 302). In the rear ell, the attic is divided into five bedrooms and one bathroom. This is also similar to the layout described in the 1920's records.
